# PROPOSED HISTORIC DISTRICT DESIGN GUIDELINES

City of Leesburg

Prepared by  
Bill Wiley  
Planning and Zoning Manager  
The Department of

Community Development  
City of Leesburg  
August 2002

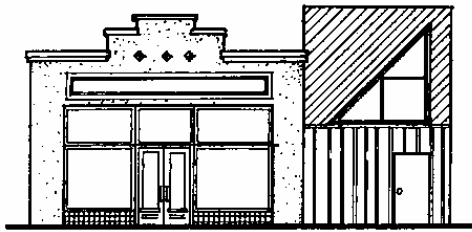
Inappropriate Addition

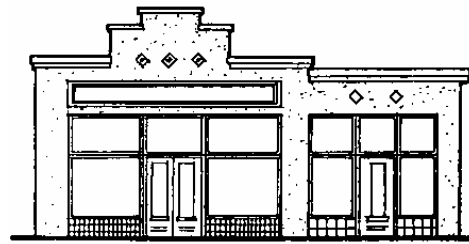
Appropriate Addition

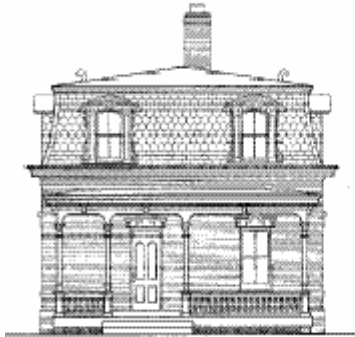
Second Empire with mansard roof

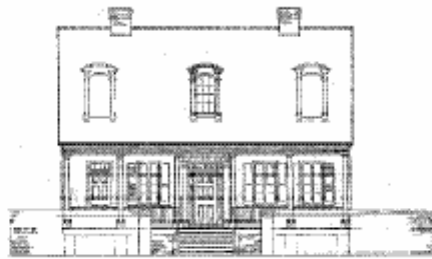
Creole Cottage –  
End gable with porches under main roof

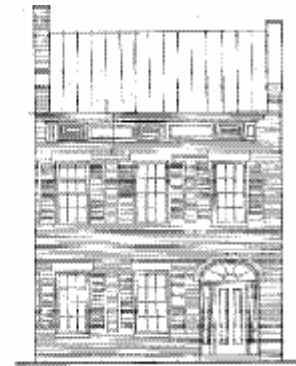
Townhouse –  
End gable with parapets

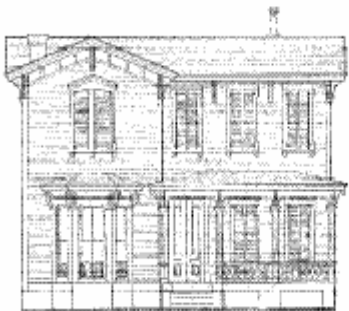
Italianate – Cross gable roof with shallow-hipped porch

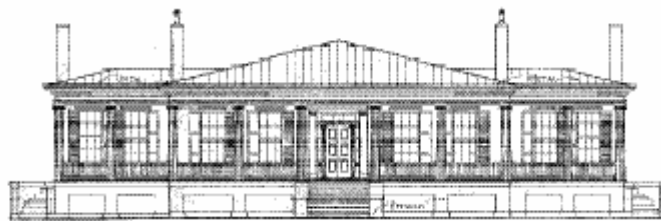
Greek Revival Raised Cottage – Hipped roof with hipped wings

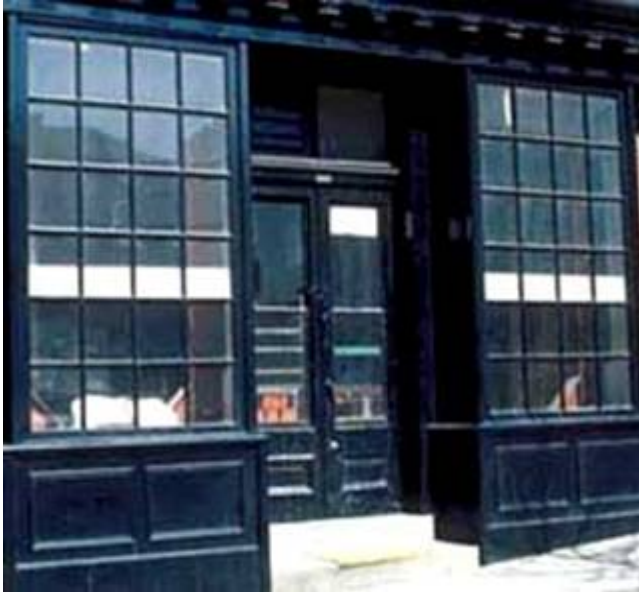
This cast iron storefront from the late 19th century has been well maintained over the years. Photo: NPS files

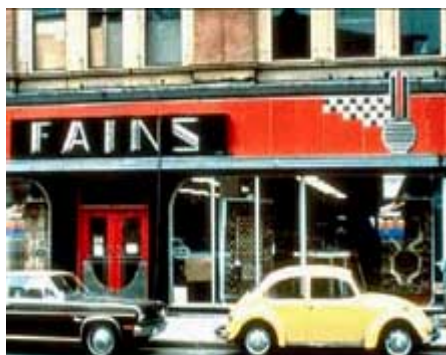
This 1930s Moderne storefront has gained significance over time and should be preserved. Photo: NPS files

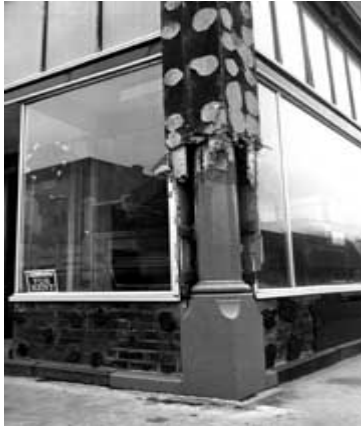
Storefronts of the 1940s, 50s, and 60s were frequently installed by attaching studs or a metal grid over an early front and applying new covering materials. Photo: Bob Dunn

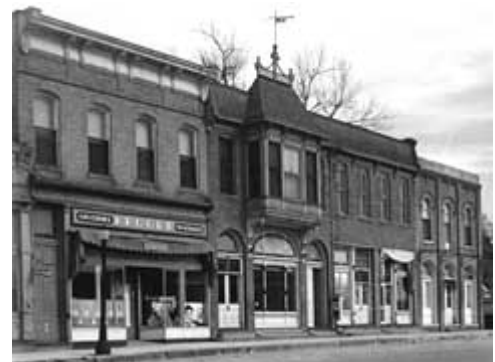
By evaluating the components of a storefront as well as their existing condition, a successful rehabilitation is more likely. Photo: HABS collection, NPS.

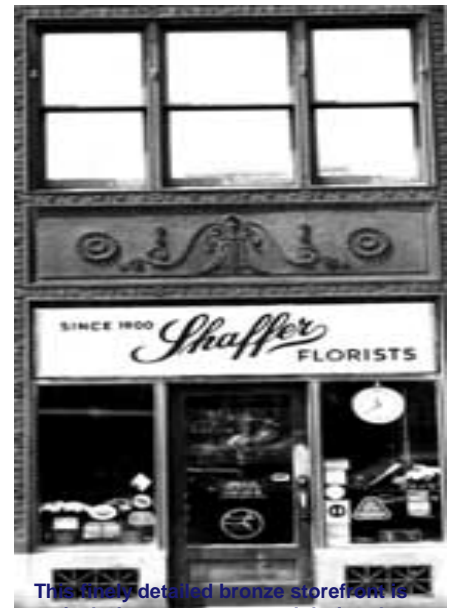
This finely detailed bronze storefront is typical of many constructed during the 1920s. The original grilles, spandrel panel and windows are all intact. Photo: NPS files.

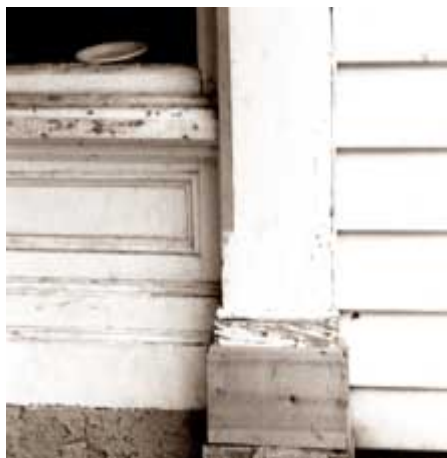
The key to the successful rehabilitation of wooden storefronts is a careful evaluation of existing physical conditions. Moisture, vandalism, insect attack, and lack of maintenance can all contribute to the deterioration of wooden storefronts. Paint failure should not be mistakenly interpreted as a sign that the wood is in poor condition and therefore irreparable. Wood is frequently in sound physical condition beneath unsightly paint. An ice pick or awl may be used to test wood for soundness--decayed wood that is jabbed will lift up in short irregular pieces; sound wood will separate in long fibrous splinters.

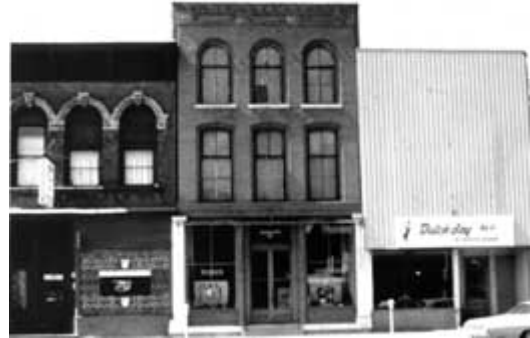
This photograph shows the impact of preserving historic storefronts. The one on the right has been totally obscured by a "modern" front added in the 1950s. Photo: NPS files.

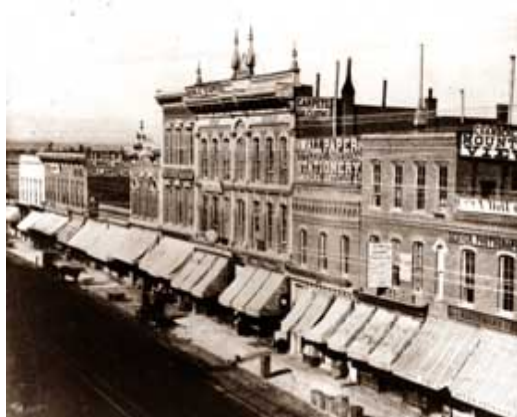
Try to locate old photographs or prints to determine what alterations have been made to the storefront and when they were undertaken. Awnings were common elements of storefronts at the turn of the century. Photo: NPS files
